North View Home Inspections L.L.C.

Home Inspection Report

Undisclosed Address

Inspected on Sun, Oct 19 2014 at 11:56 AM

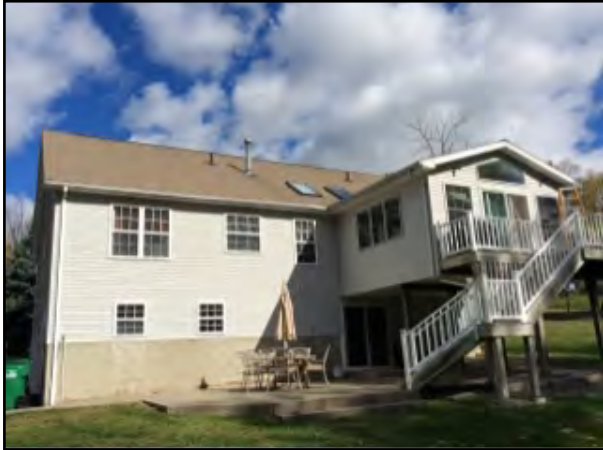
Figure 1-1

The roof shingles are a three tab asphalt shingle approximately 21 years old. The average life expectancy is usually 20 - 25 years. The shingles are in marginal condition with some wear and particulates in the gutters. Budget for a new roof in 3 -5 years.

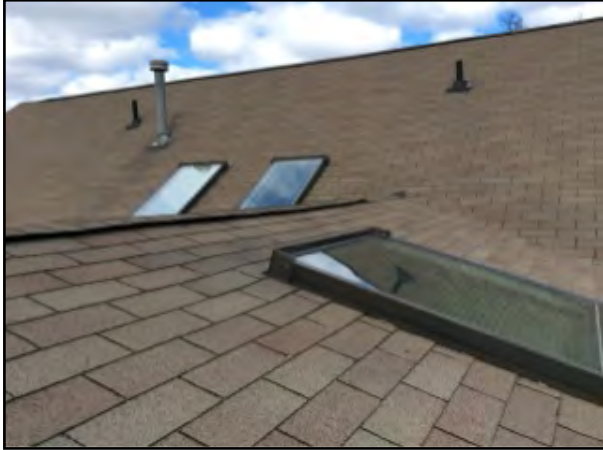
Figure 2-1

One or more sections of the roof covering in the front of the house appears to be stained with an algae or fungus like substance. The staining and discoloration is more or a cosmetic and aesthetic issue than a defect. Recommend a qualified contractor or professional cleaning company to evaluate and make recommendations.

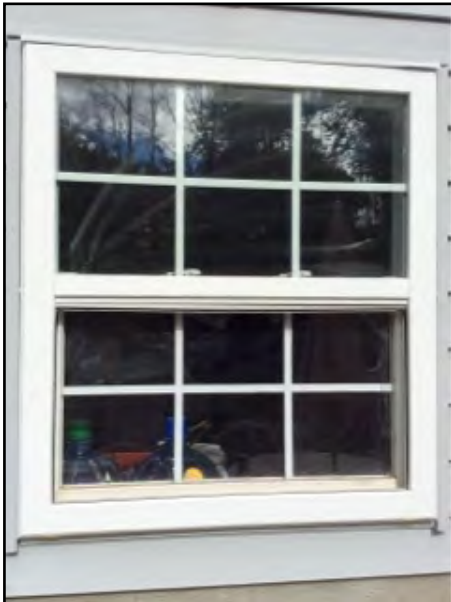
Figure 4-1

One vinyl double hung window on the ground level has a broken window pane. Repair and replace as necessary.

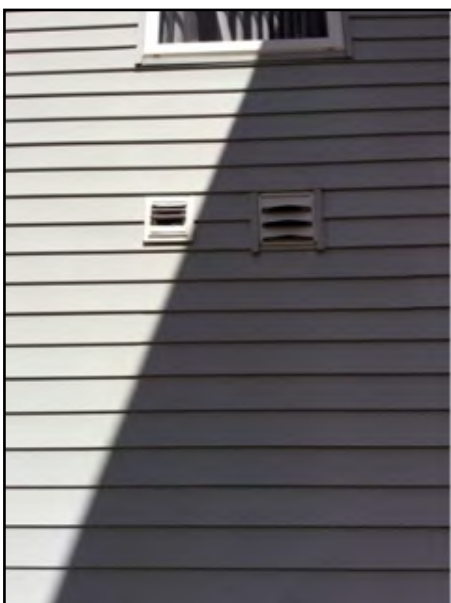
Figure 5-1

There were two exhaust vents that were stuck in the open position. One vent appears to be a dryer vent and the other could be the air intake from the mechanical room. Recommend qualified contractor to clean duct and repair as necessary.

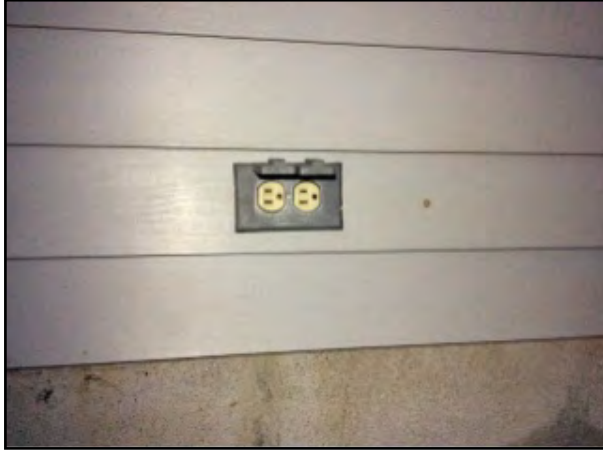
Figure 6-1

The outlet under the deck is not a GFCI protected outlet. All exterior outlets must be GFCI protected. Recommend electrician to install GFCI receptacle and repair as necessary.

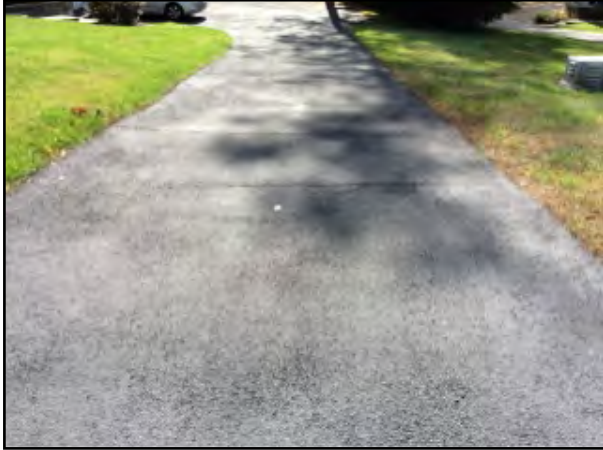
Figure 10-1

The driveway is an asphalt driveway in marginal condition. There are numerous cracks and areas of settlement in the driveway especially in front of the left side of the garage door. Recommend asphalt contractor to repair as necessary.

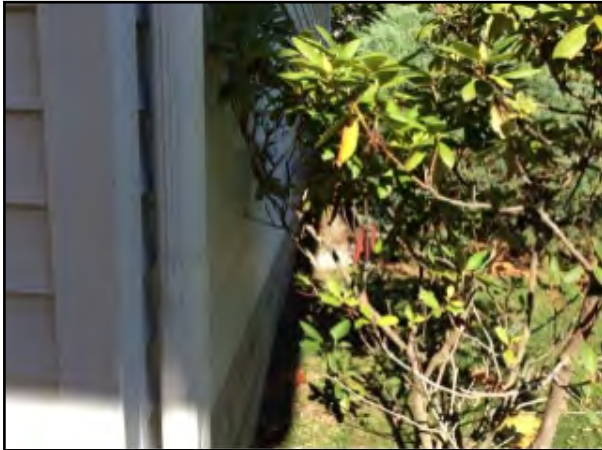
Figure 11-1

Some shrubs are in contact with the side of the house. Recommend pruning of shrubs to avoid moisture buildup.

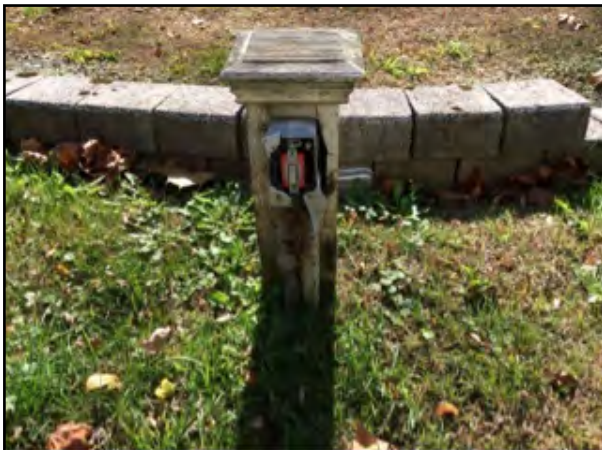
Figure 12-1

There is a missing switch plate cover for an outside power source to an abandoned pool. Recommending replacing and repairing as necessary by qualified electrician.

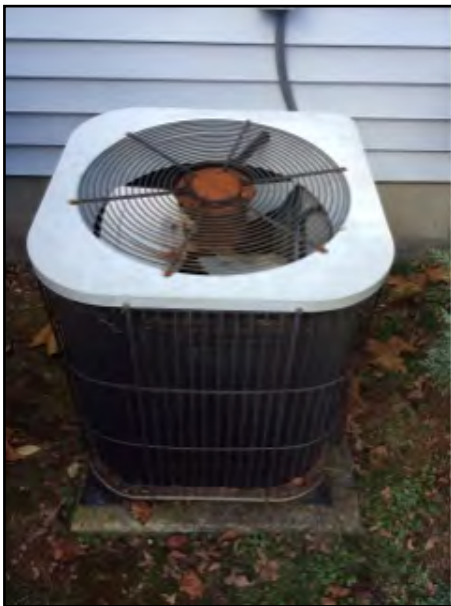
Figure 14-1

The air conditioning condenser is in marginal condition with some rust noted. The unit cannot be tested due to the ambient temperature being below 65°. Recommend qualified HVAC contractor to test the near future.

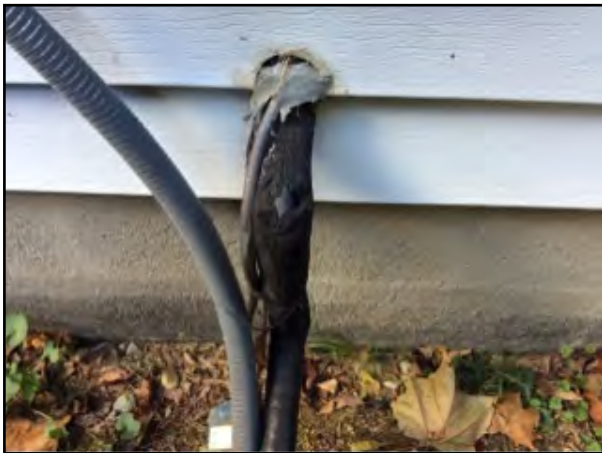
Figure 15-1

The refrigerant line to the AC condenser is missing insulation. Recommending HVAC contractor to repair as necessary.

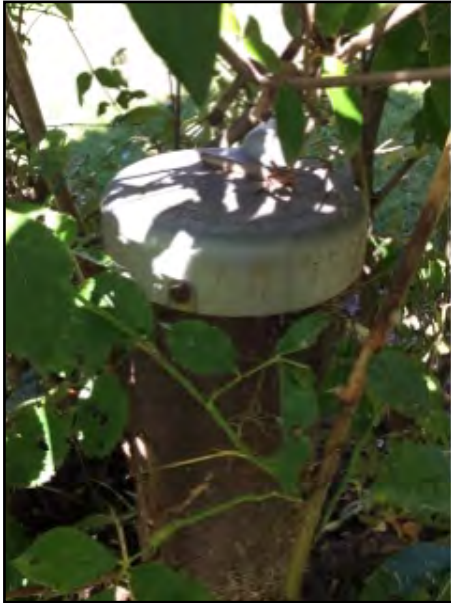
Figure 16-1

The well head cap located in the front yard is not a sanitary well cap. This can allow bacteria and other elements to infiltrate the water supply. This is a health issue and recommend qualified well contractor to assess and make recommendation.

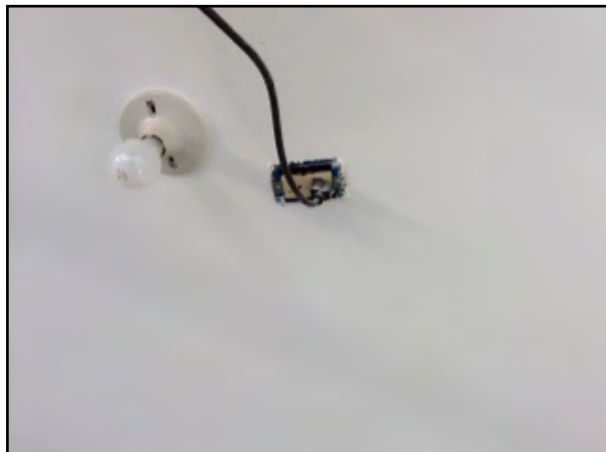
Figure 17-1

Garage ceiling outlet is missing switch plate cover. Recommend electrician to repair and replace as necessary with new switch plate cover.

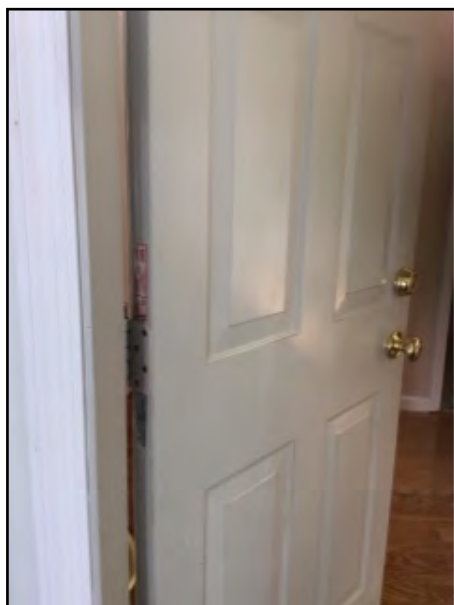
Figure 18-1

The interior garage door was a fire rated door however it not self close. Recommend carpenter contractor to repair as necessary.

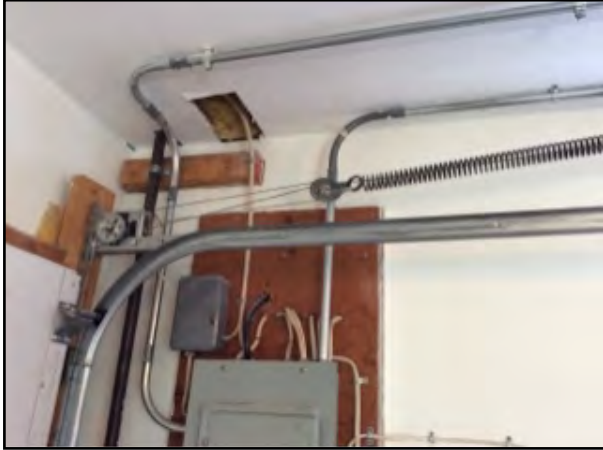
Figure 19-1

The garage ceiling had an area missing sheet rock above the electric panel. This can allow exhaust fumes to enter the living space above. Recommend contractor to repair as necessary.

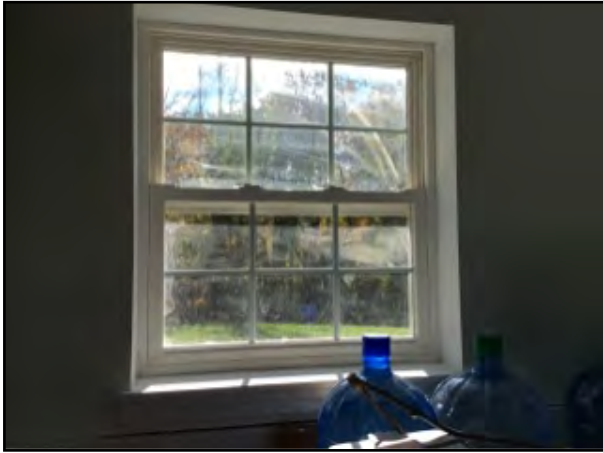
Figure 21-1

The window in the storage room next to the garage has a broken window pane. Recommend qualified contractor to repair as necessary.

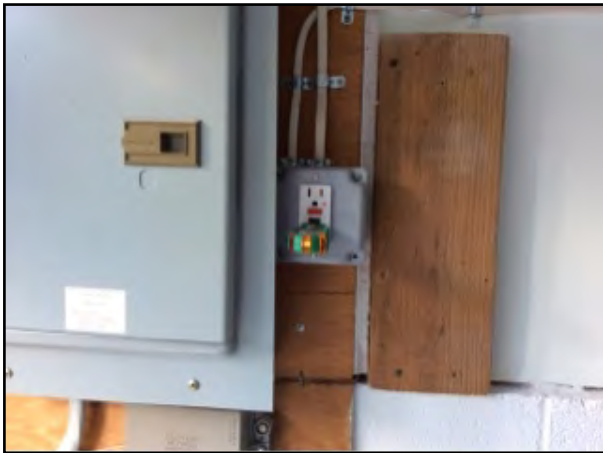
Figure 22-1

There were a total of three outlets in the garage on the walls and two outlets on the ceiling. All outlets in a garage must be GFCI protected. Recommend electrician to replace outlets with GFCI protected outlets.

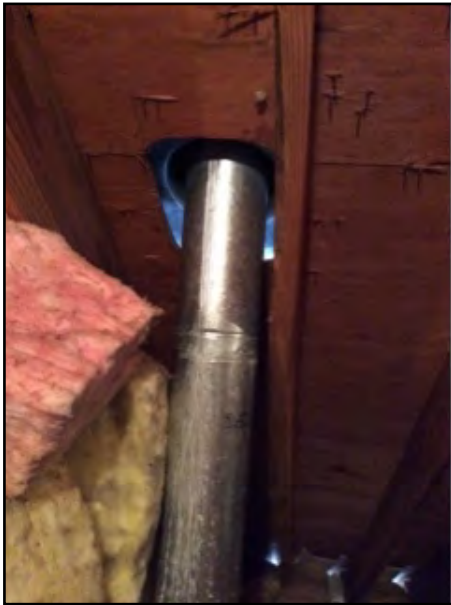
Figure 26-1

The chimney flue pipe had some daylight showing from in the inside of the attic. This area might be susceptible to a wind driven rain and allow water to penetrate to the interior. Recommend roofing contractor to evaluate and repair as necessary.

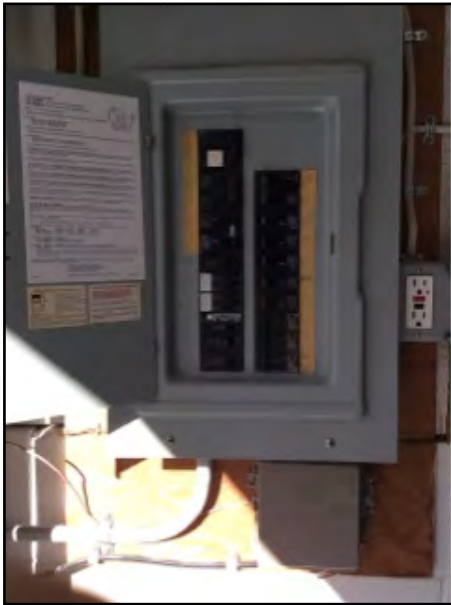
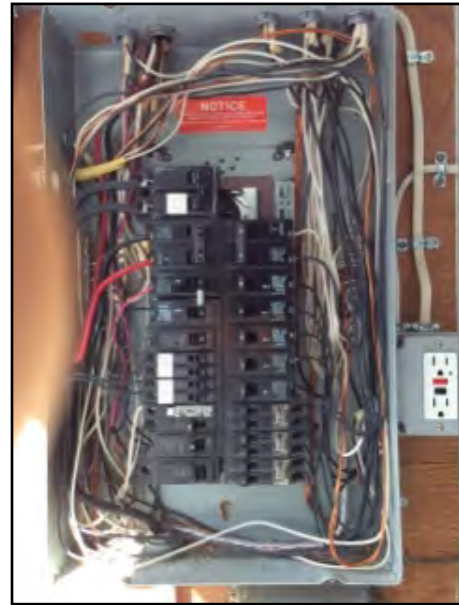
The electric panel is located in the garage and appears to be in satisfactory condition with no defects noted and grounded properly. However, there is no additional room in the electric panel for expansion. All circuit breakers are labeled. There appears to be no double tap breakers.

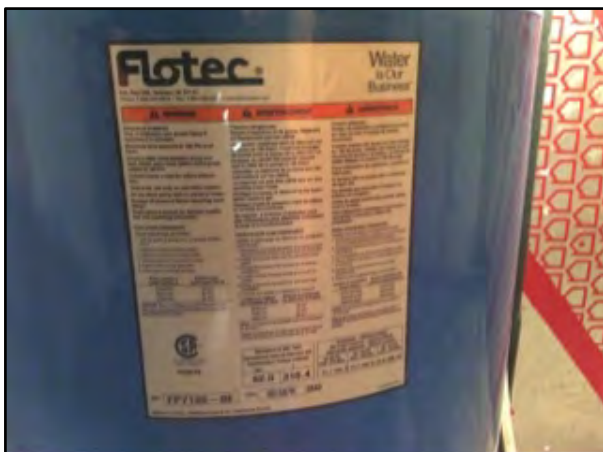
Figure 30-1

Electric control box is missing a cover for the well tank. Recommend electrician to find and install cover.

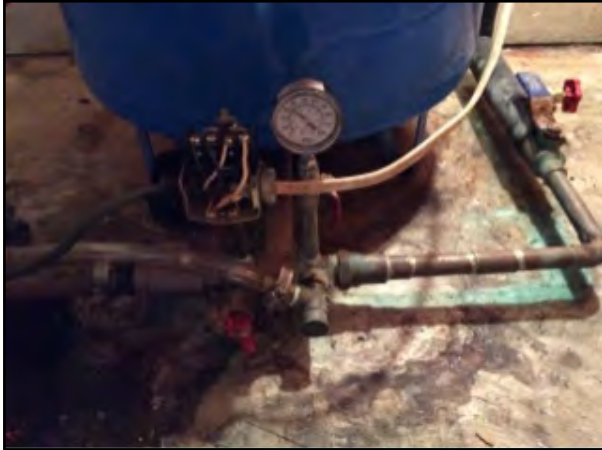
Figure 31-1

The well tank is in satisfactory condition with no visible signs of rust on the tank. Water was ran for 30 minutes and had adequate pressure. The main shut off lever for the water supply is rusted and corroded. Recommend plumbing contractor to evaluate and repair as necessary.

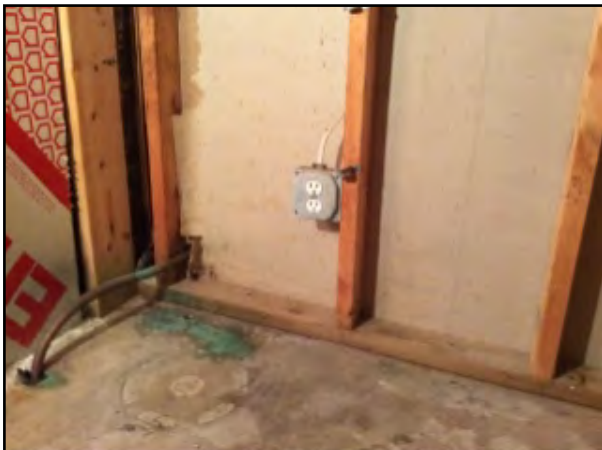
Figure 32-1

Electrical outlet is in close proximity to the well tank and is not a GFCI protected outlet. Recommend electrician to install GFI outlet.

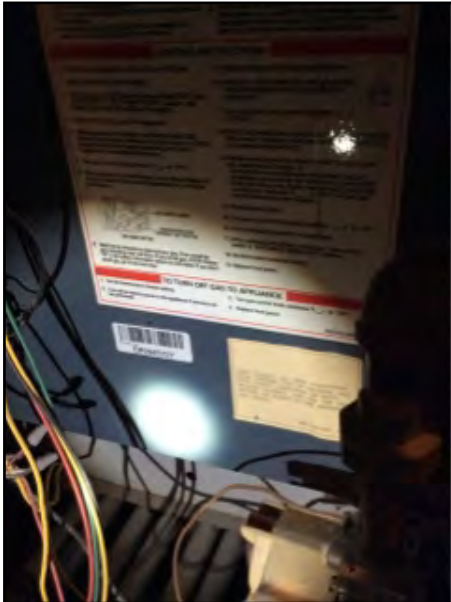
Figure 34-1

The pressure relief valve leading from the boiler to the hot water maker is rusted and there is evidence of water leak. There was no pipe extending to the floor for the TPRV on the boiler. Recommend plumber to repair as necessary

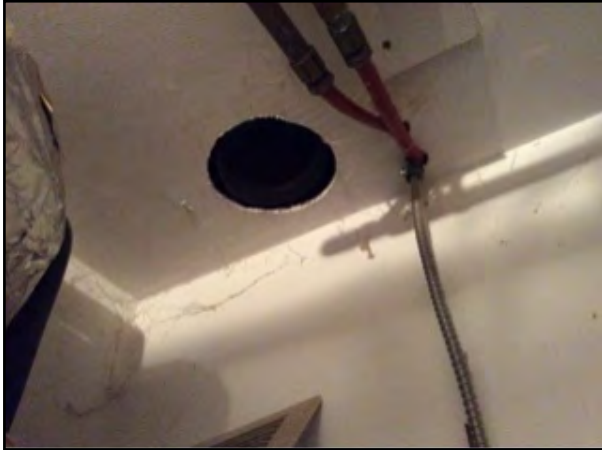
Figure 35-1

There was a vent pipe exposed in the ceiling of the laundry room next to the boiler. It appears that this is providing ventilation for the interior boiler and laundry room. Recommend HVAC contractor to determine if the vent pipe vents to the exterior.

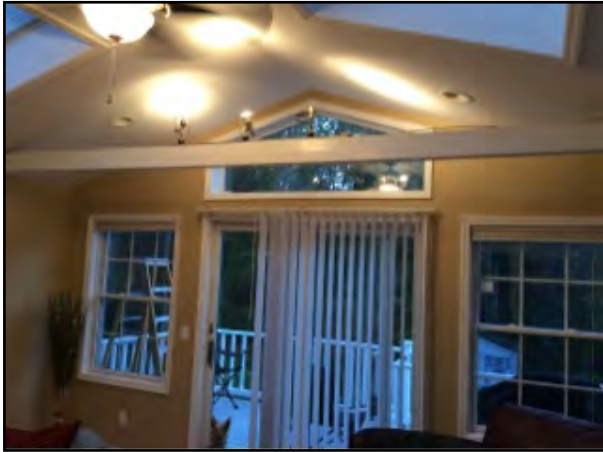
Figure 51-1

The four seasons sunroom is in good condition with no major defects noted. The floor had radiant heat and appeared to be working properly on the day of inspection. However, there is a small water stain noted at bottom of skylight on the left side. Recommend monitoring during next rain to see if this is an active leak.

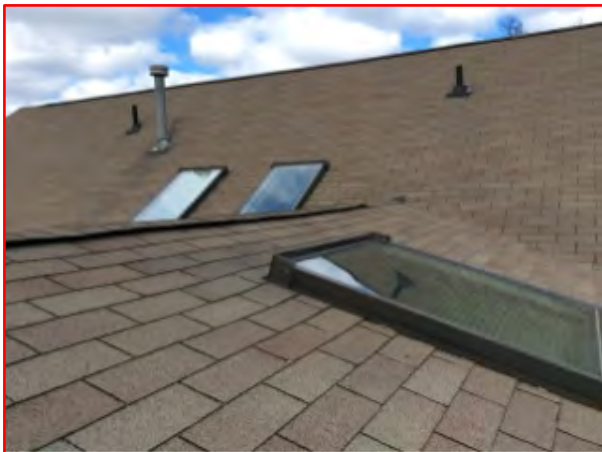
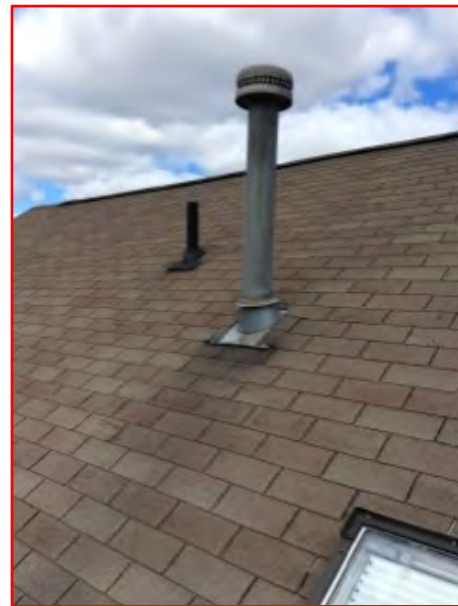
1)
One or more sections of the roof covering in the front of the house appears to be stained with an algae or fungus like substance. The staining and discoloration is more or a cosmetic and aesthetic issue than a defect. Recommend a qualified contractor or professional cleaning company to evaluate and make recommendations.

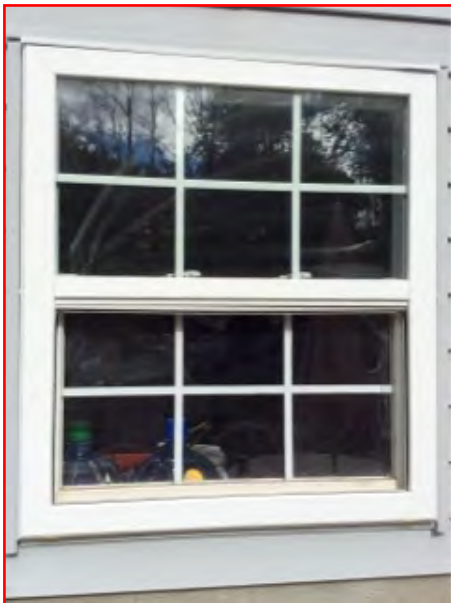
Figure 2-1

One vinyl double hung window on the ground level has a broken window pane. Repair and replace as necessary.

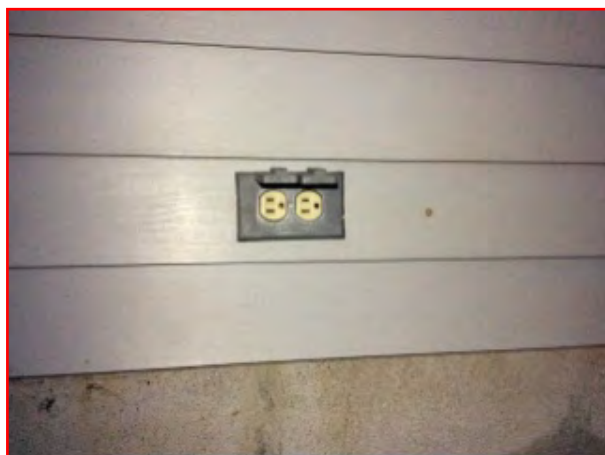
Figure 4-1

The outlet under the deck is not a GFCI protected outlet. All exterior outlets must be GFCI protected. Recommend electrician to install GFCI receptacle and repair as necessary.

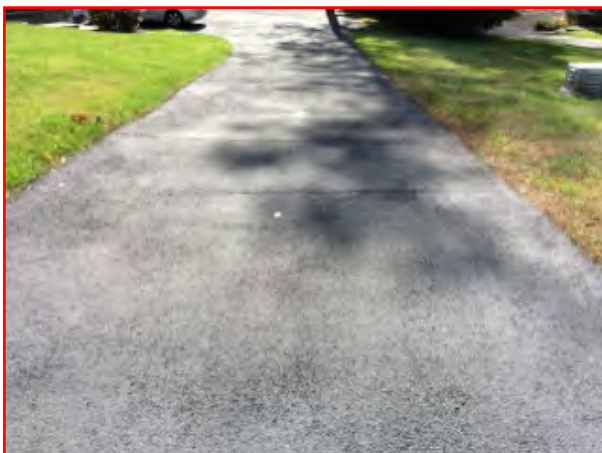
Figure 8-1

The driveway is an asphalt driveway in marginal condition. There are numerous cracks and areas of settlement in the driveway especially in front of the left side of the garage door. Recommend asphalt contractor to repair as necessary.

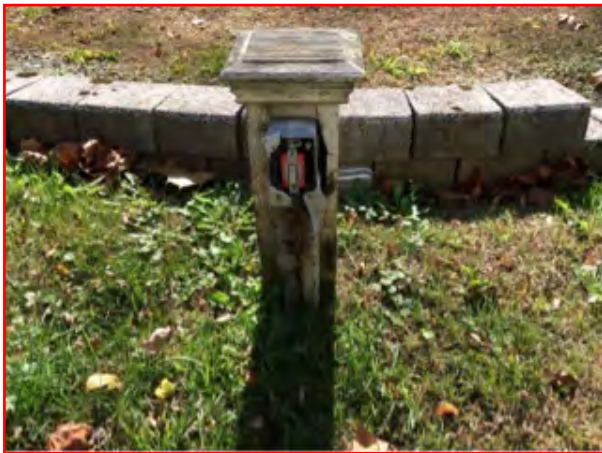
Figure 9-1

9) There is a missing switch plate cover for an outside power source to an abandoned pool. Recommending replacing and repairing as necessary by qualified electrician.

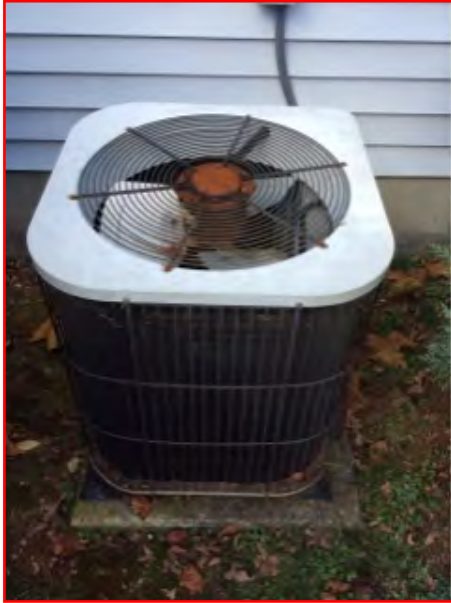
Figure 11-1

The air conditioning condenser is in marginal condition with some rust noted. The unit cannot be tested due to the ambient temperature being below 65° Recommend qualified HVAC contractor to test the near future.

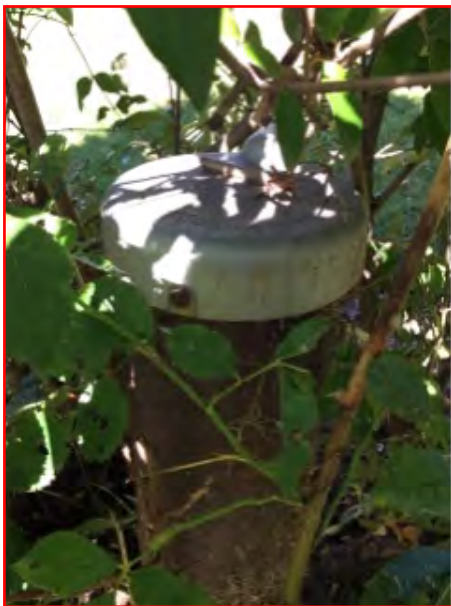
Figure 13-1

The well head cap located in the front yard is not a sanitary well cap. This can allow bacteria and other elements to infiltrate the water supply. This is a health issue and recommend qualified well contractor to assess and make recommendation.

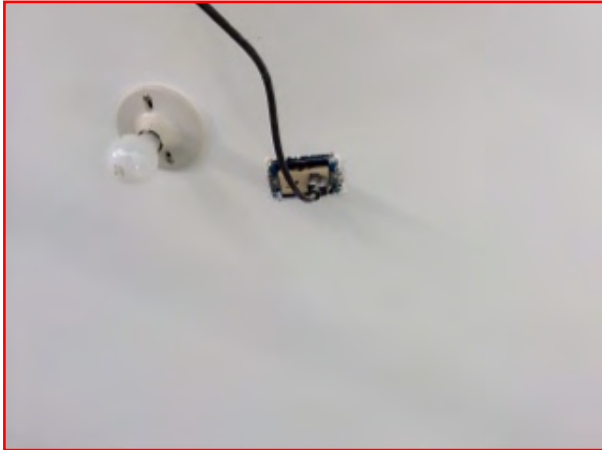
Figure 14-1

Garage ceiling outlet is missing switch plate cover. Recommend electrician to repair and replace as necessary with new switch plate cover.

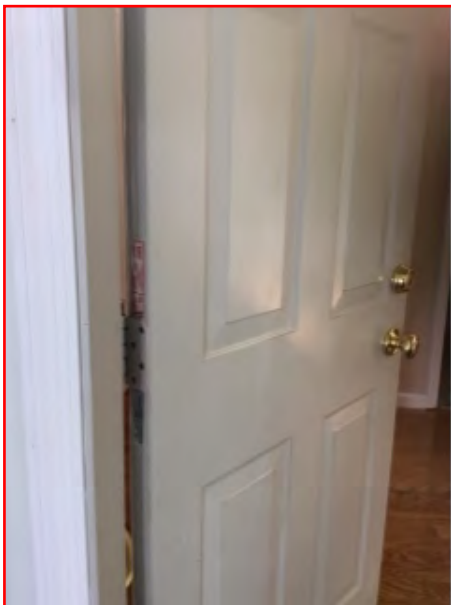
Figure 15-1

15) The interior garage door was a fire rated door however it not self close. Recommend carpenter contractor to repair as necessary.

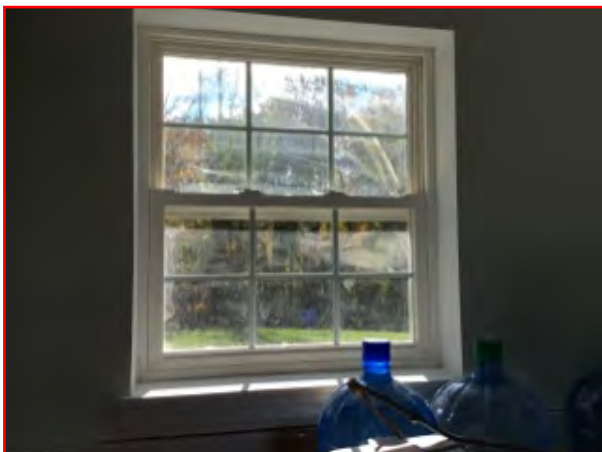
Figure 17-1

The window in the storage room next to the garage has a broken window pane. Recommend qualified contractor to repair as necessary.

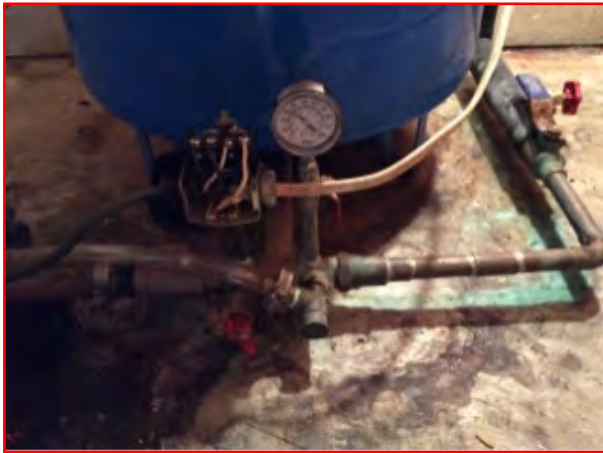
Figure 22-1

The well tank is in satisfactory condition with no visible signs of rust on the tank. Water was ran for 30 minutes and had adequate pressure. The main shut off lever for the water supply is rusted and corroded. Recommend plumbing contractor to evaluate and repair as necessary.

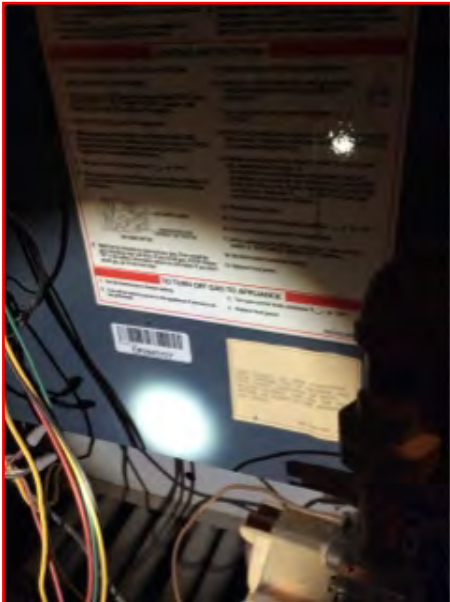
Figure 24-1

The pressure relief valve leading from the boiler to the hot water maker is rusted and there is evidence of water leak. There was no pipe extending to the floor for the TPRV on the boiler. Recommend plumber to repair as necessary
