North View Home Inspections L.L.C.

Home Inspection Report

Undisclosed Address

Inspected on Sun, Oct 19 2014 at 11:56 AM

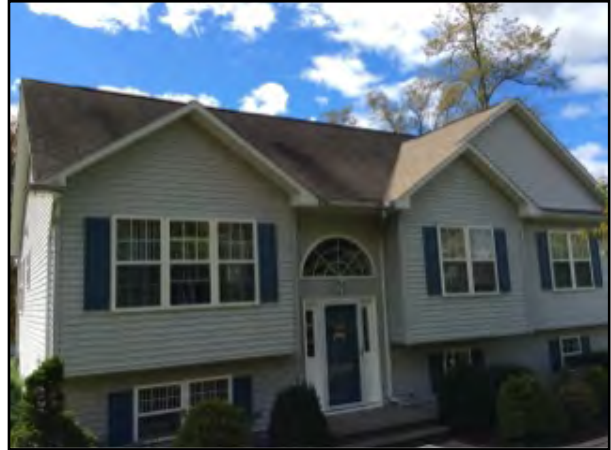
Figure 1-2

The roof shingles are a three tab asphalt shingle approximately 21 years old. The average life expectancy is usually 20 - 25 years. The shingles are in marginal condition with some wear and particulates in the gutters. Budget for a new roof in 3 -5 years.

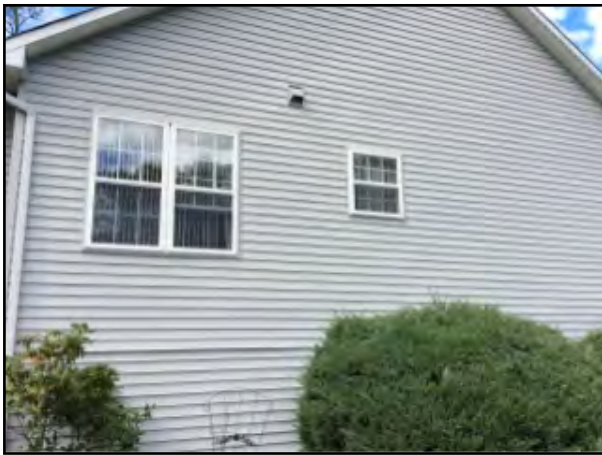
Figure 3-1

The exterior wall covering and soffits are a vinyl product. The fascia trim is wrapped in aluminum. These areas do not require painting. The siding, fascias and soffits are in good condition.

The gutters are aluminum and appear to be pitched properly to divert rain water to the downspouts. The downspouts are tied into an underground pipe or drainage system. Inspector was not able to verify if these drains are clear and are functioning properly. Recommend monitoring after a heavy rain and get a qualified contractor to test drainage system.

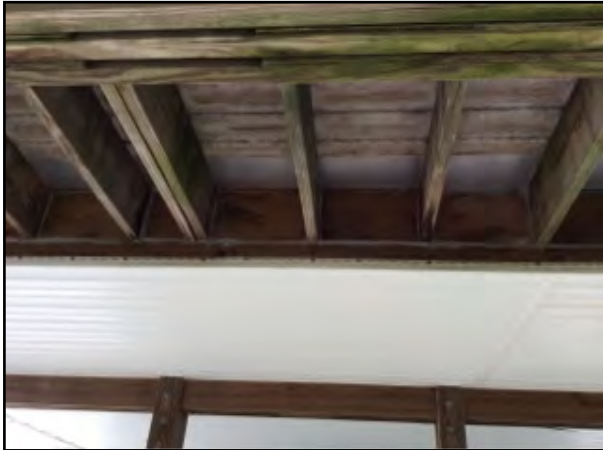
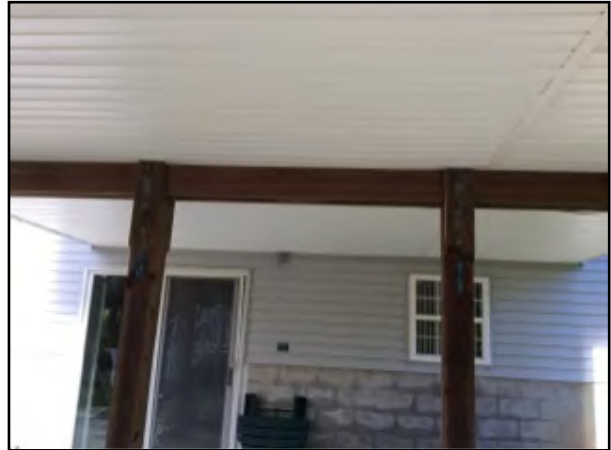
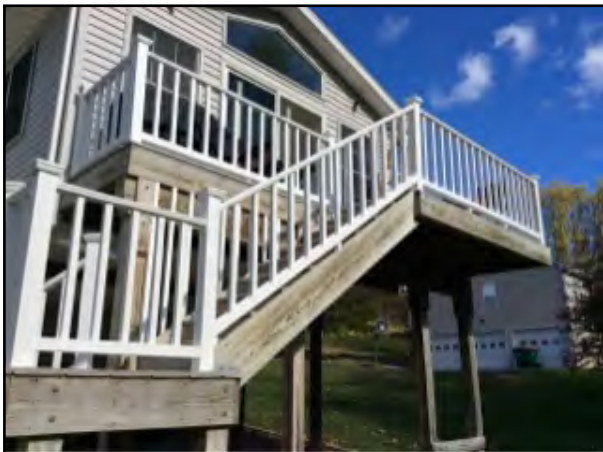
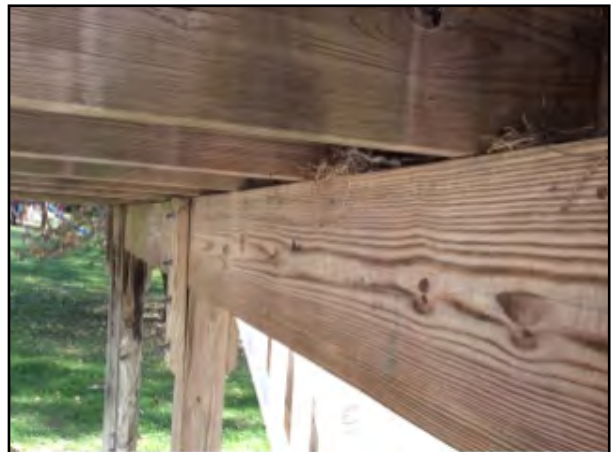
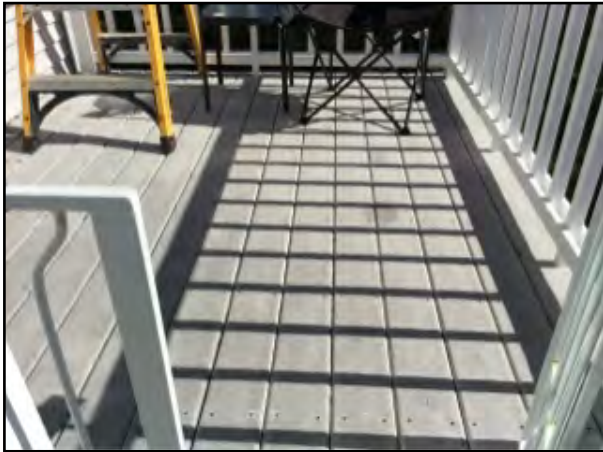
The deck consists of pressure treated framework with composite decking. The deck, support posts, girders, stairs and railings appear to be in good condition.

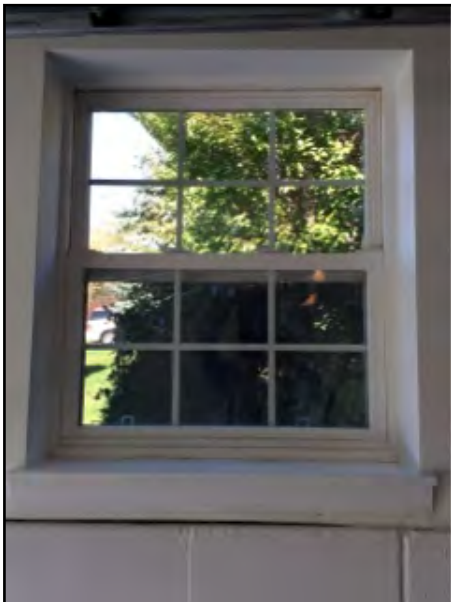
Figure 20-1

Garage windows operating as designed and were in good condition.

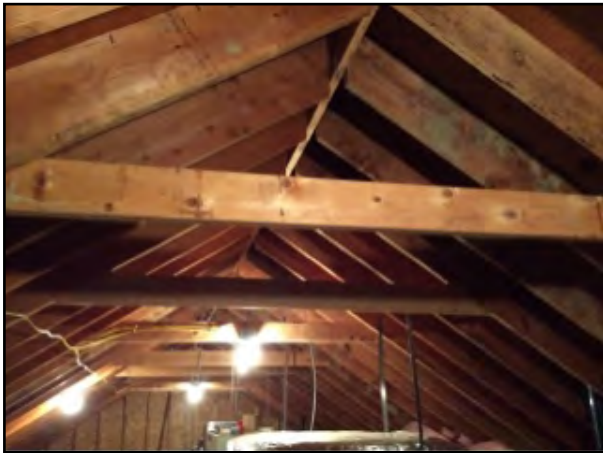
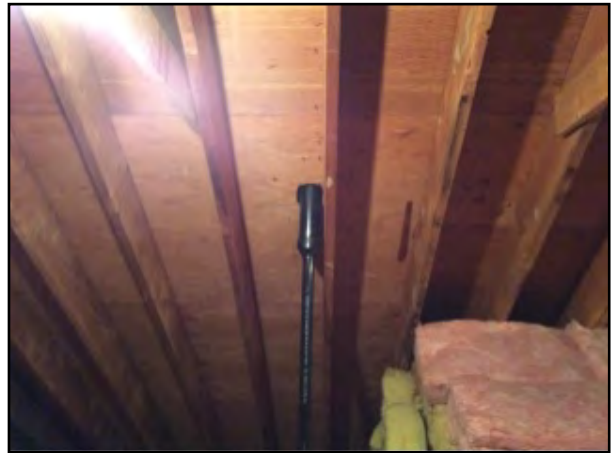
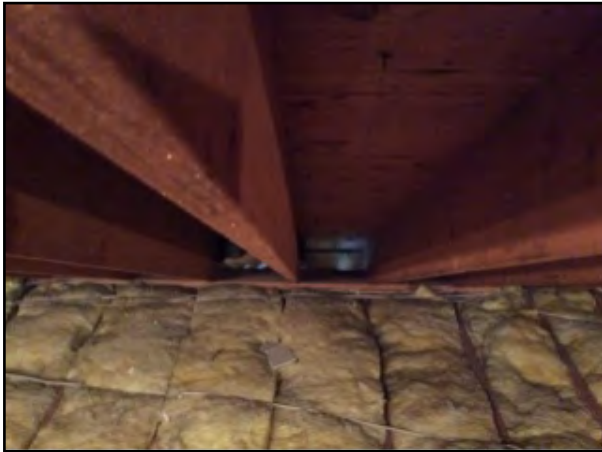
The roof sheathing appeared to be in good condition with no evidence of moisture penetration or mold. The attic was well insulated and had proper ventilation from the soffits to the ridge.

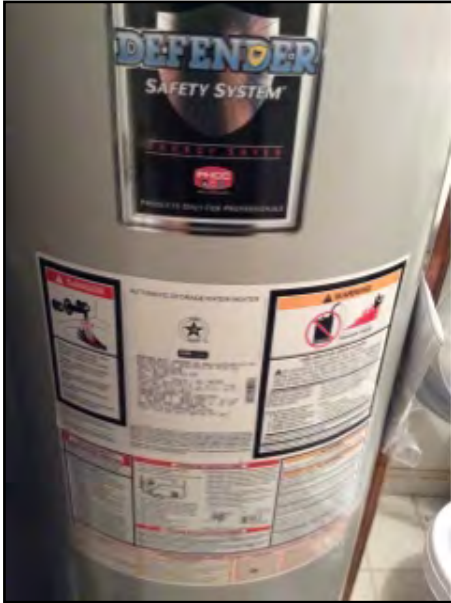
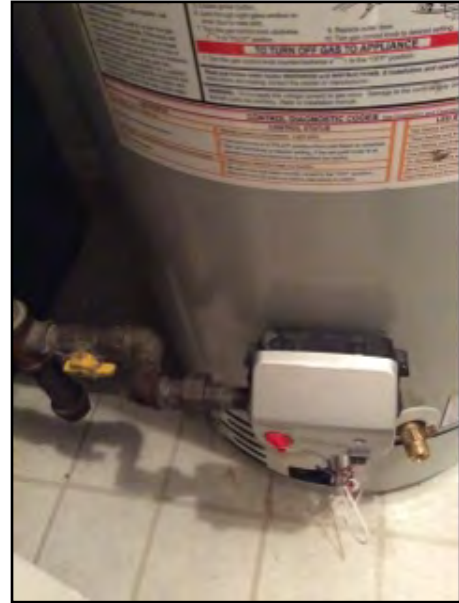
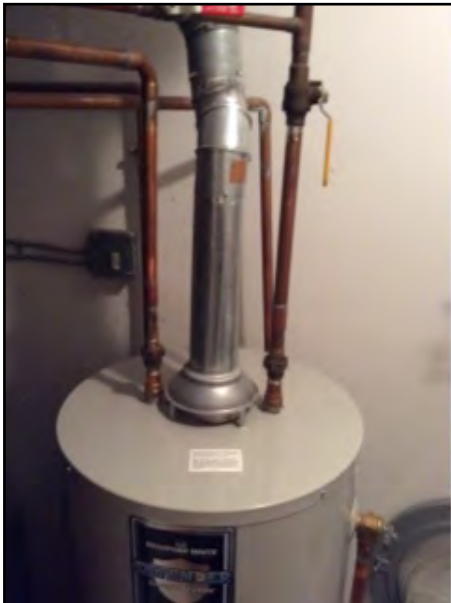
The water heater is a 40 gallon gas fired unit located in the basement which operated properly on the date of inspection. The tank showed no signs of rust or corrosion and the TPRV temperature pressure relief valve were noted and at a proper location. Hot water was received at all plumbing fixtures in the home.

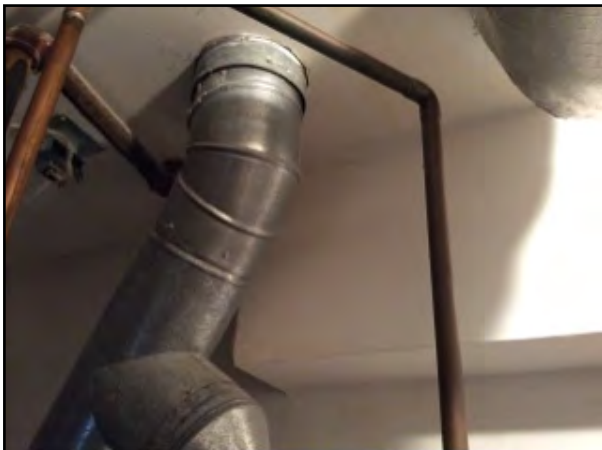
Figure 36-1

Flue pipes from the boiler which carry carbon monoxide gases to the exterior are pitched and sealed properly and in good condition.

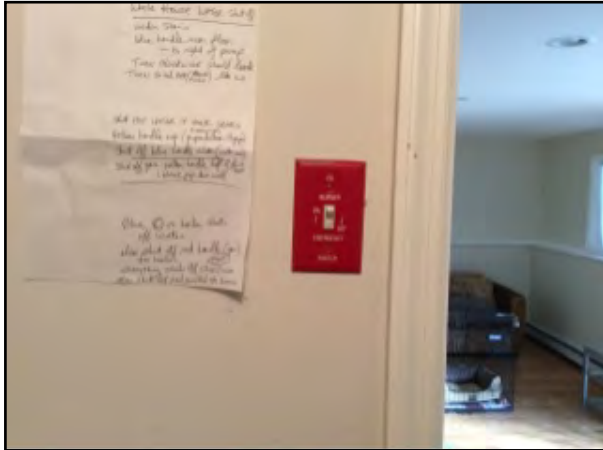
Figure 37-1

There was one emergency switch for the oil burner located on the wall in the laundry room.

Furnaces over 10 years old should be checked, cleaned and serviced yearly by a licensed contractor.

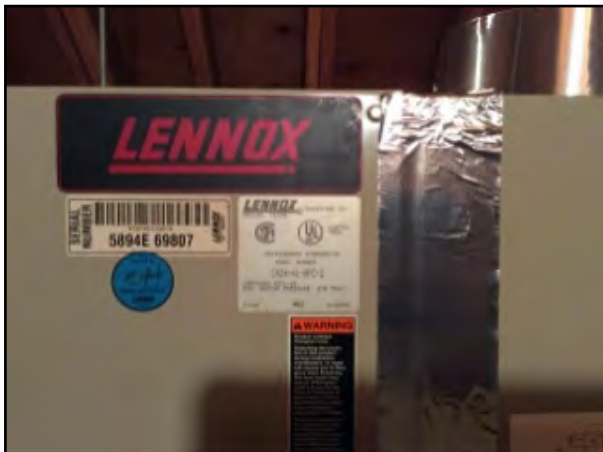
Figure 38-1

Did not operate air conditioning unit due to the ambient temperature being below 65°.

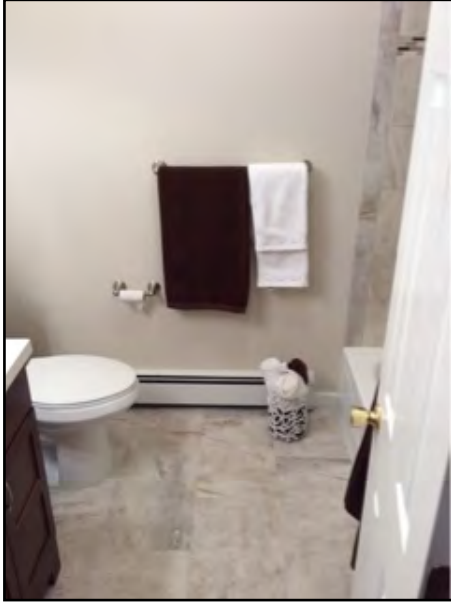
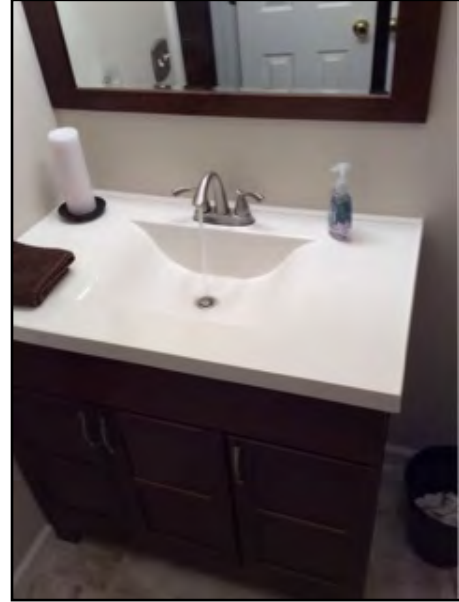
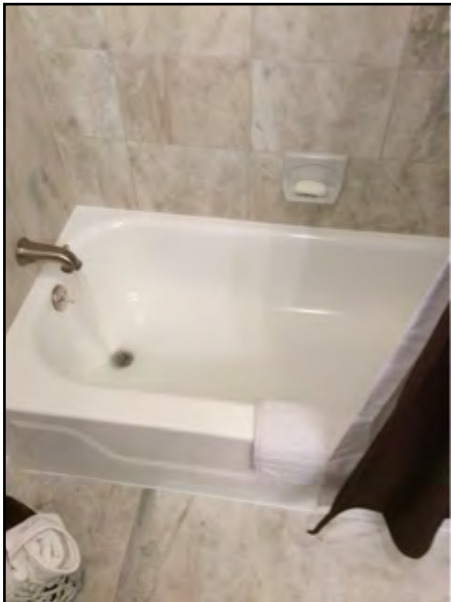
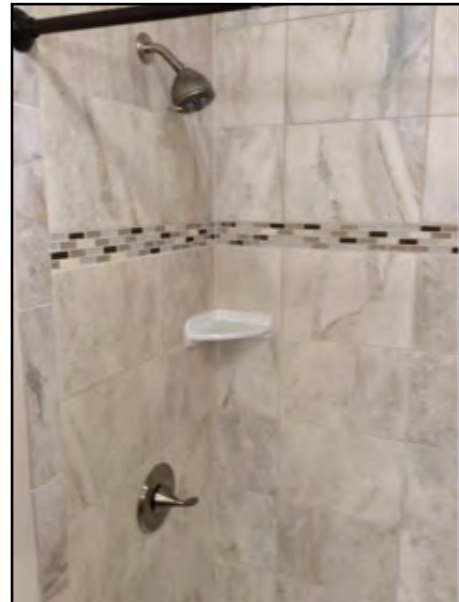
The first floor bathroom was in good condition with no apparent defects . All fixtures were tested and found no leaks. The bathroom had an exhaust fan for ventilation and had no visible signs of mold or mildew.

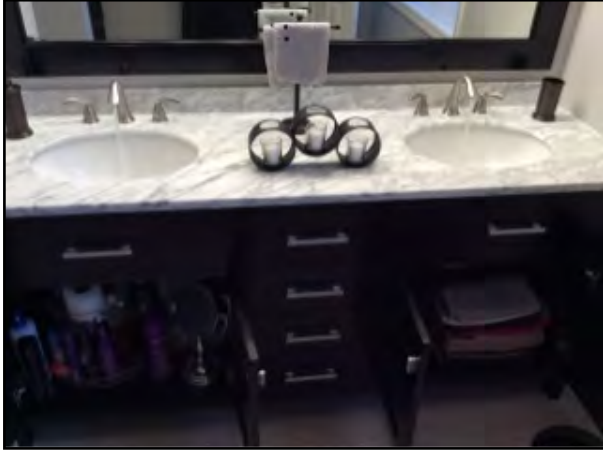
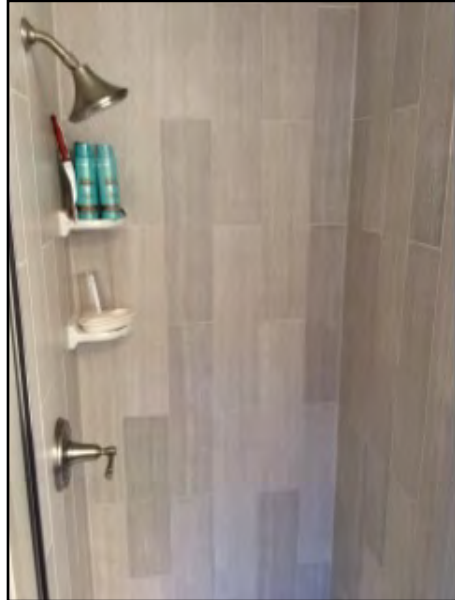
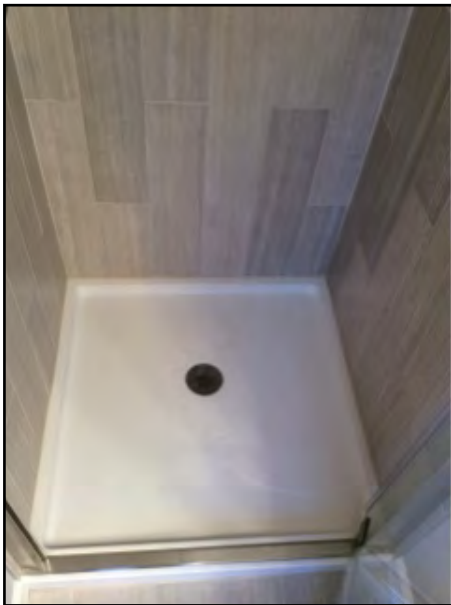
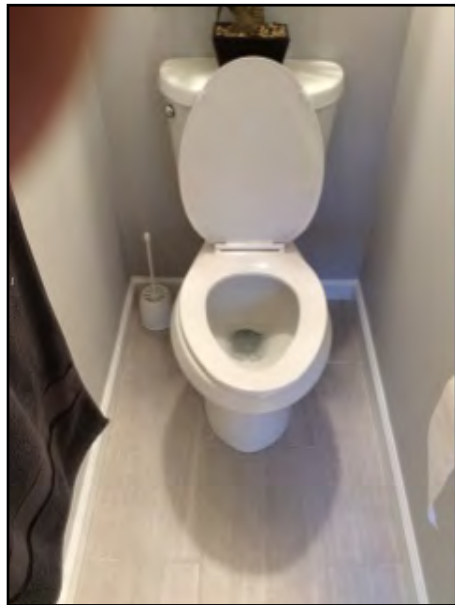
The master bathroom fixtures appear to be in good working condition with no leaks noted at the sinks, toilet and shower. There was an exhaust fan for ventilation and no mold or mildew was noted on the walls and ceiling.

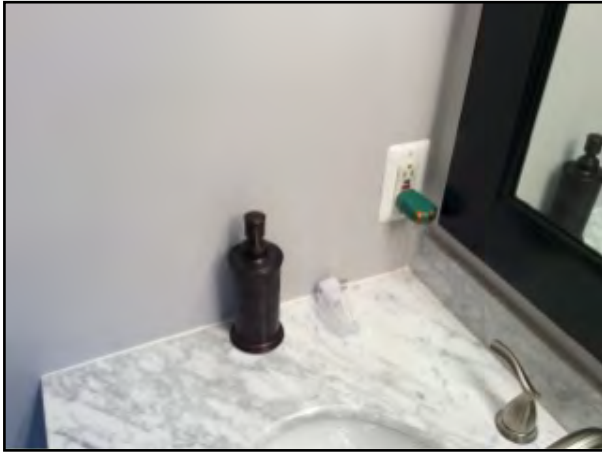
Figure 43-1

The GFCI outlet in the master bathroom is present and is in working condition at time of inspection.

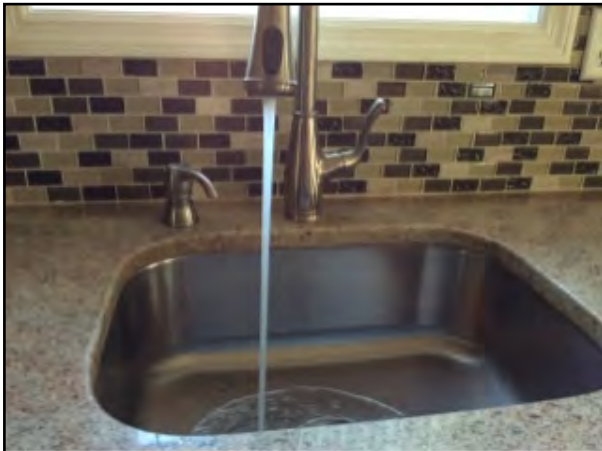
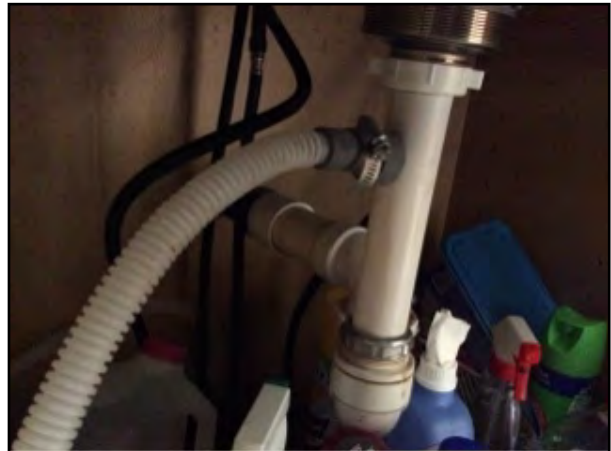
Kitchen sink is functional with no evidence of a water leak. There is an old water stain on the ceiling below the kitchen and it appears to be an old stain.

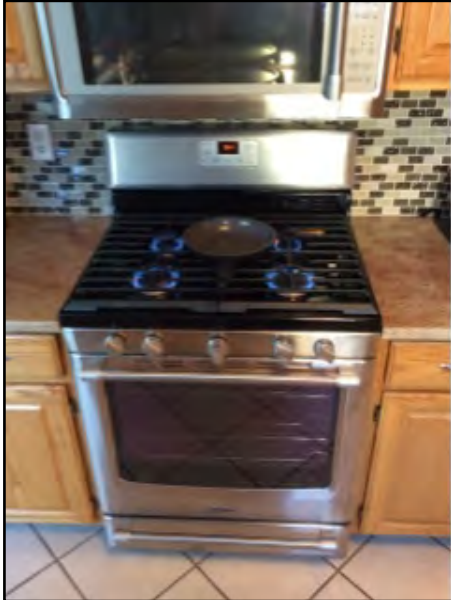
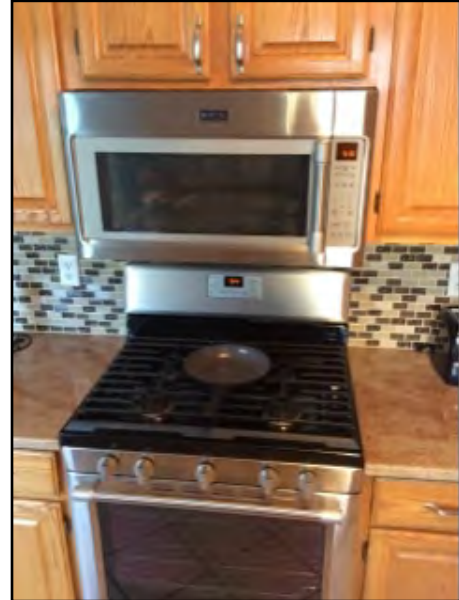
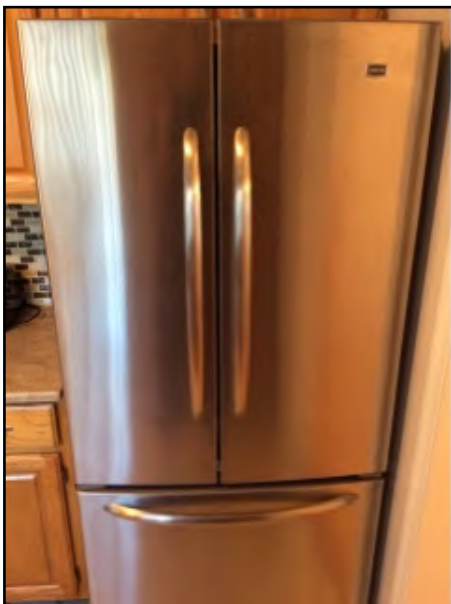
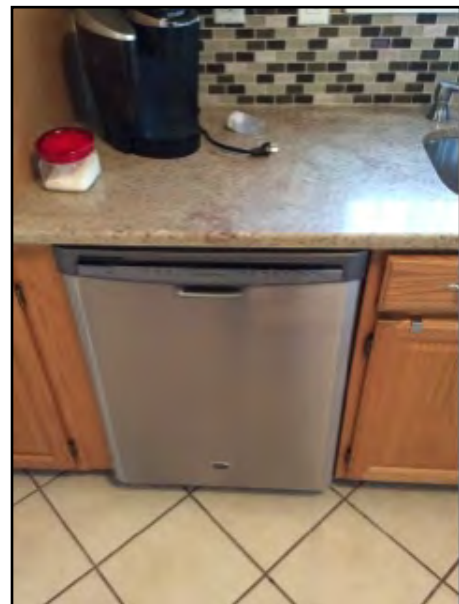
All kitchen appliances were tested and in good working condition at the time of inspection. The gas stove was vented to the exterior by a microwave exhaust fan and operated properly.

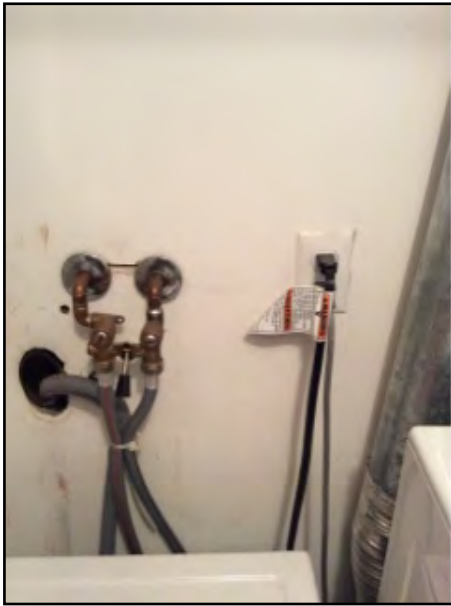
Figure 46-1

The outlet in the laundry room is in close proximity to the water source for the washing machine. This is a safety issue. Recommend electrician to install a GFCI outlet in laundry room.

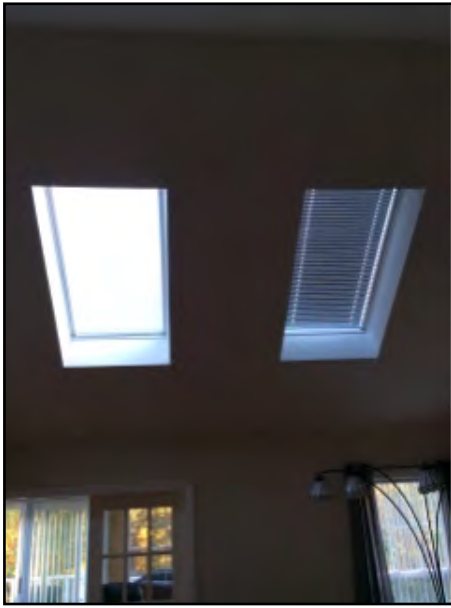
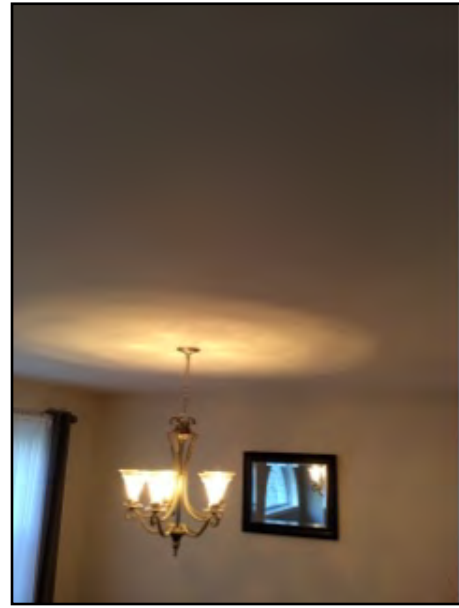
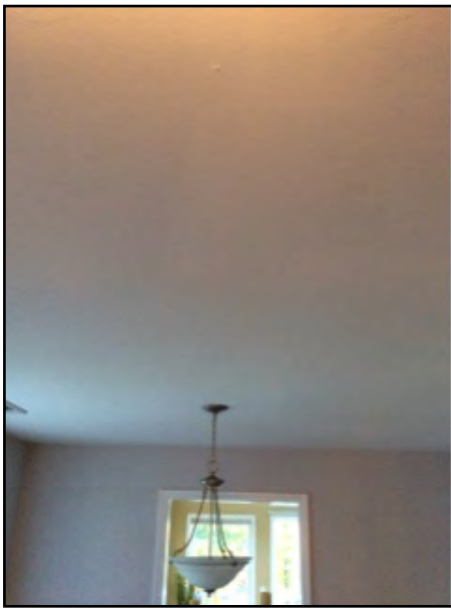
The interior was in overall good condition with no major defects noted. Ceilings and walls are sheetrock and are in good condition. All floor surfaces were level with no bounce and were in good condition. The electrical outlets were three pronged grounded outlets and randomly tested with no defects on the tested outlets. Windows are vinyl insulated and were randomly tested and operated properly.

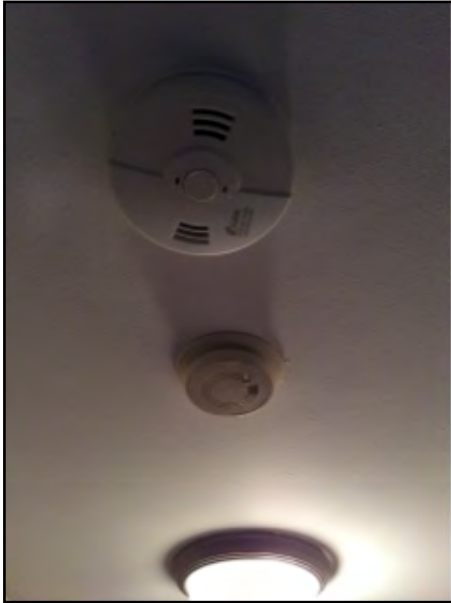
Figure 49-1

Bedrooms and upstairs hallway had operating smoke detectors and carbon monoxide detectors and were operating at the time of inspection. Smoke and carbon monoxide batteries should be changed and tested often to ensure they are operational.

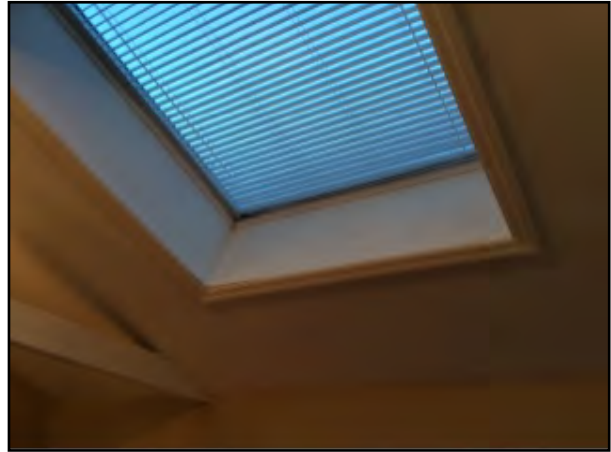
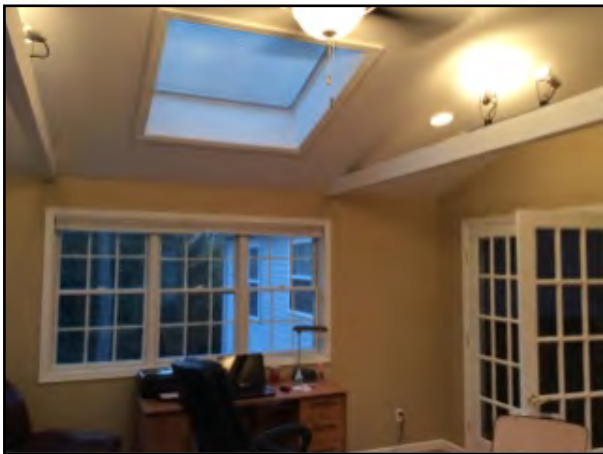
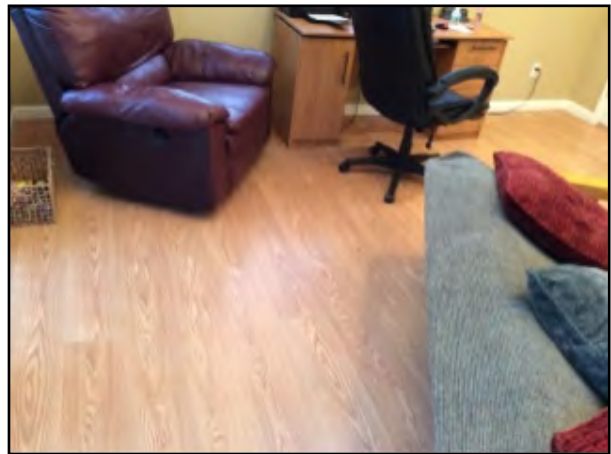
The four seasons sunroom is in good condition with no major defects noted. The floor had radiant heat and appeared to be working properly on the day of inspection. However, there is a small water stain noted at bottom of skylight on the left side. Recommend monitoring during next rain to see if this is an active leak.

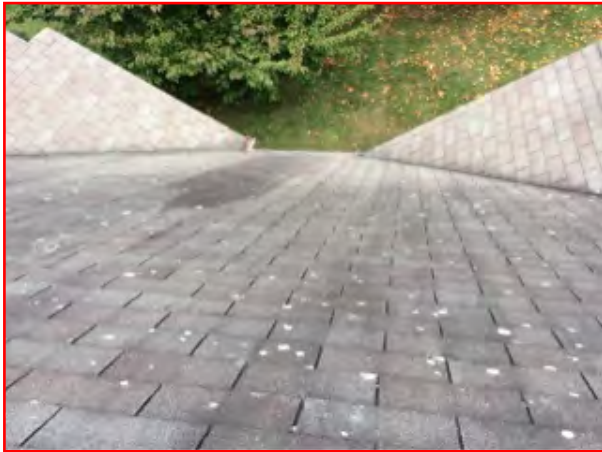
Figure 1-3

1)
One or more sections of the roof covering in the front of the house appears to be stained with an algae or fungus like substance. The staining and discoloration is more or a cosmetic and aesthetic issue than a defect. Recommend a qualified contractor or professional cleaning company to evaluate and make recommendations.

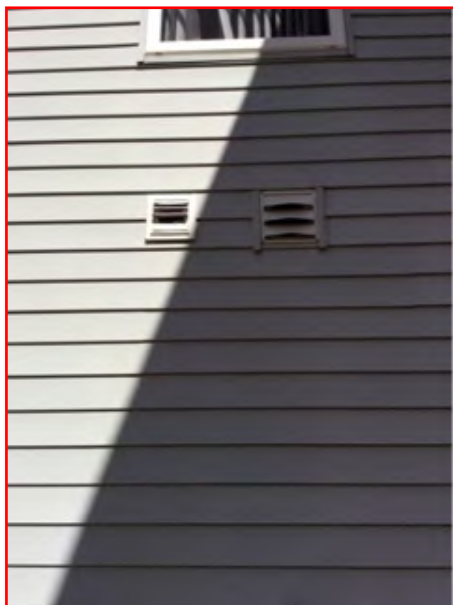
Figure 3-1

3) There were two exhaust vents that were stuck in the open position. One vent appears to be a dryer vent and the other could be the air intake from the mechanical room. Recommend qualified contractor to clean duct and repair as necessary.

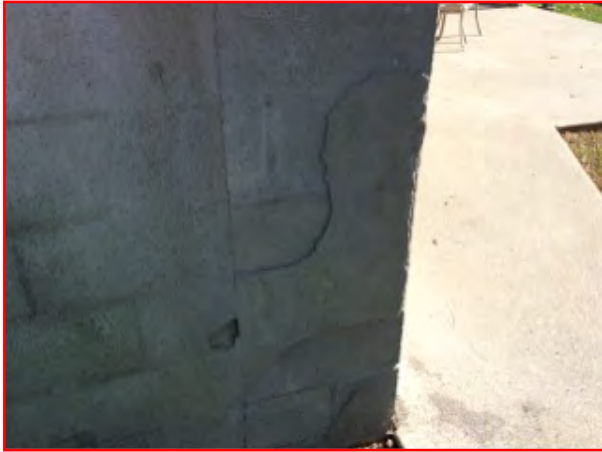
Figure 7-1

The exterior foundation walls are made up of concrete block. There are some areas that have loose or missing stucco. Recommend mason contractor to repair as necessary.

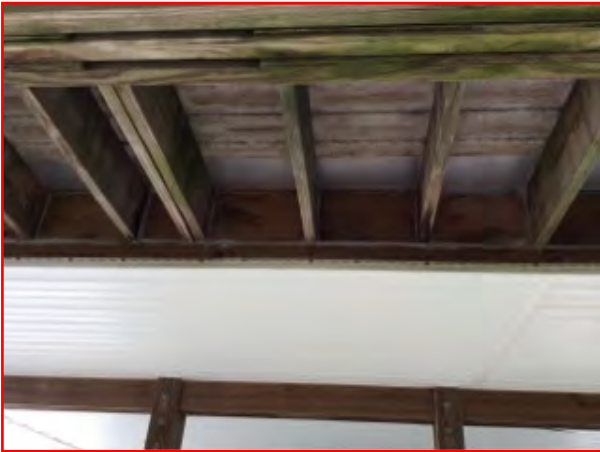
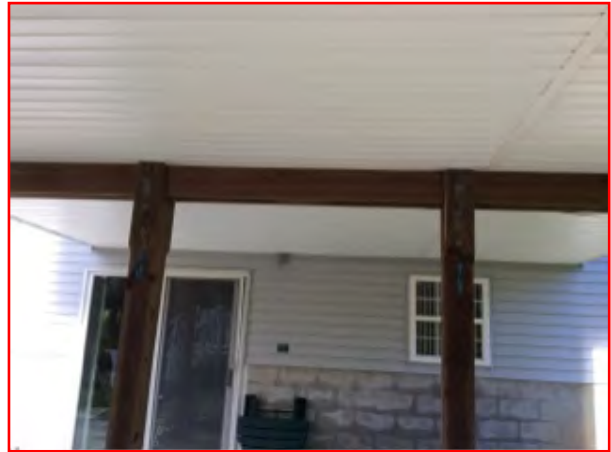
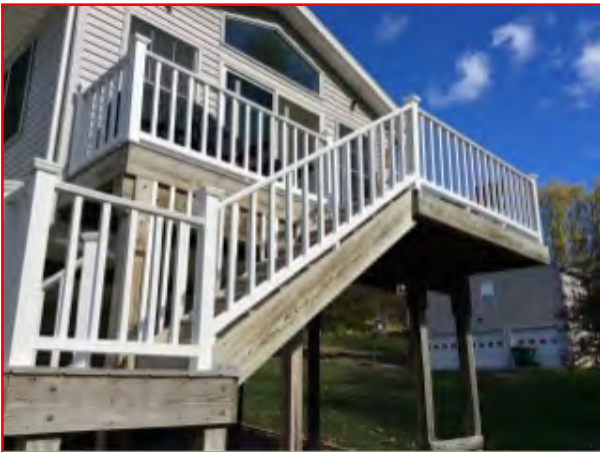
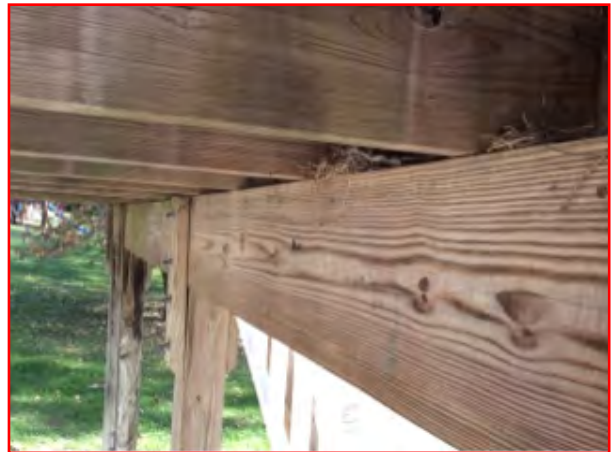
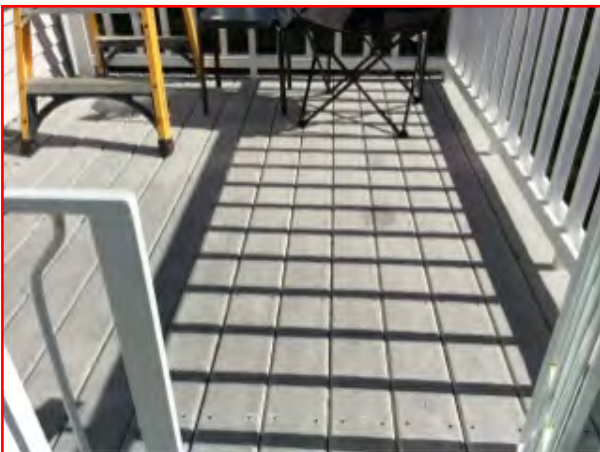
10)
The deck consists of pressure treated framework with composite decking. The deck, support posts, girders, stairs and railings appear to be in good condition.

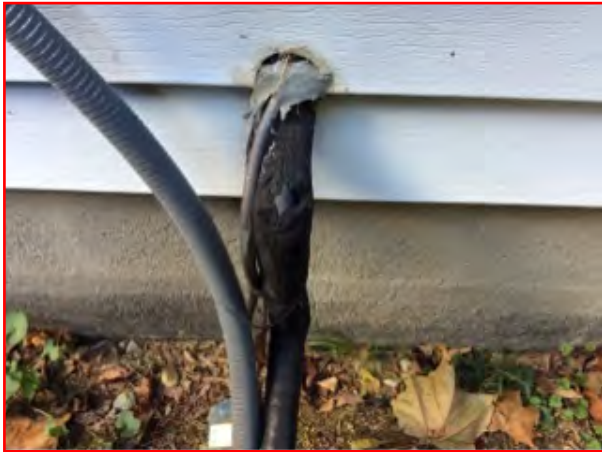
Figure 12-1

The refrigerant line to the AC condenser is missing insulation. Recommending HVAC contractor to repair as necessary.

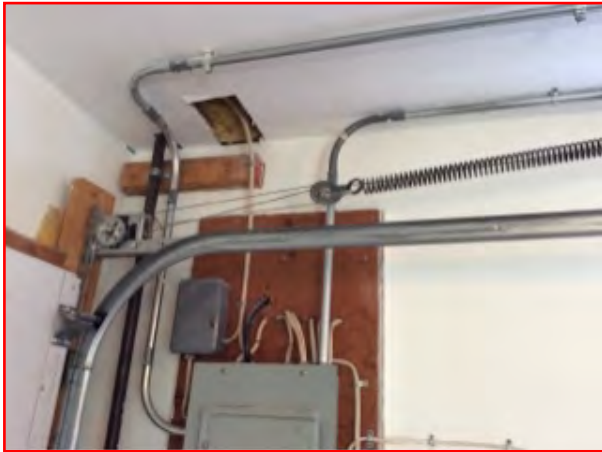
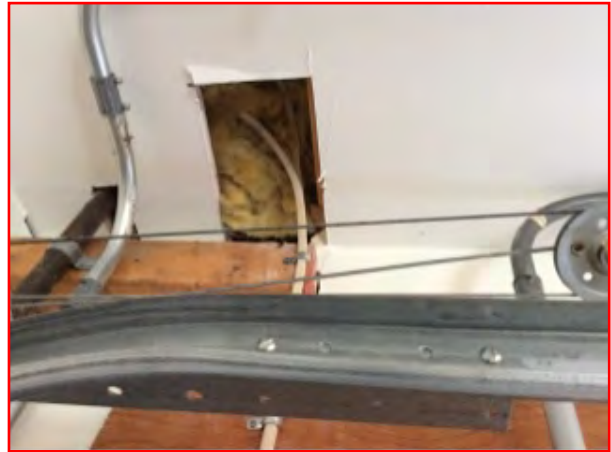
The garage ceiling had an area missing sheet rock above the electric panel. This can allow exhaust fumes to enter the living space above. Recommend contractor to repair as necessary.

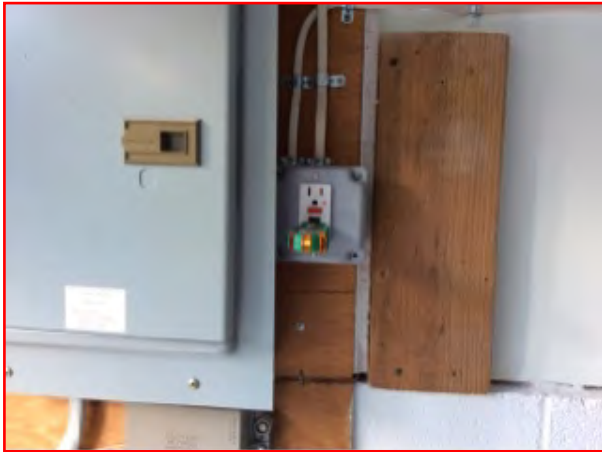
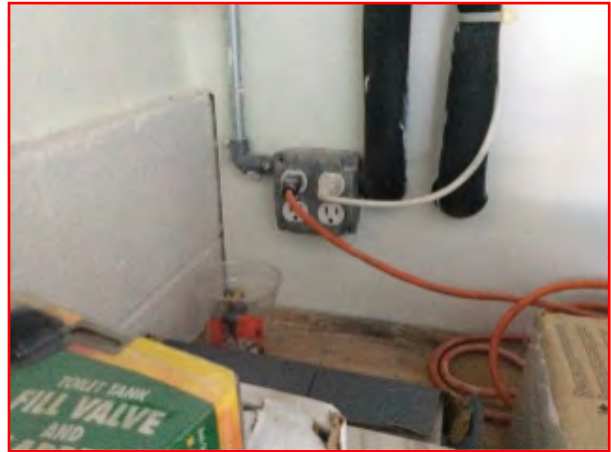
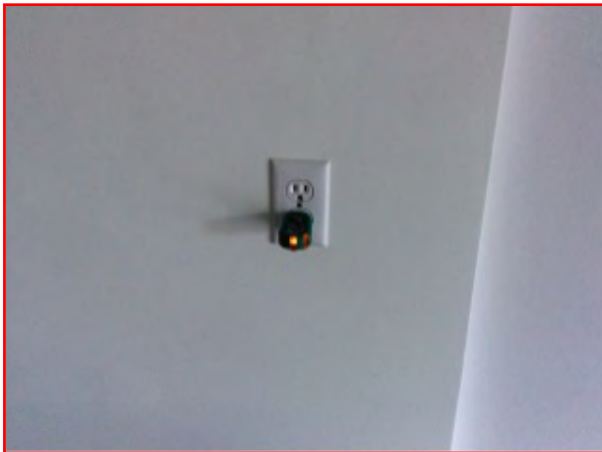
There were a total of three outlets in the garage on the walls and two outlets on the ceiling. All outlets in a garage must be GFCI protected. Recommend electrician to replace outlets with GFCI protected outlets.

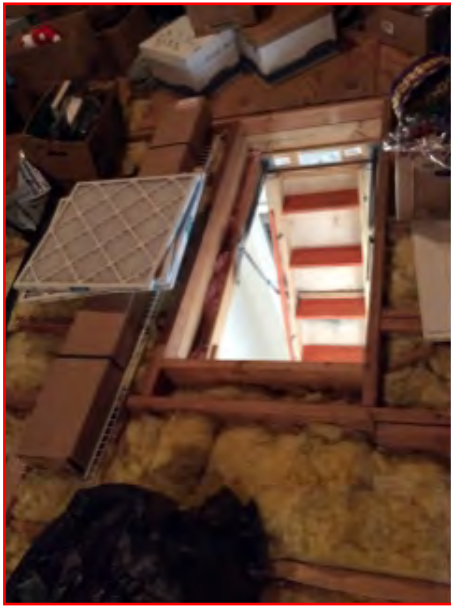
Figure 19-1

The attic floor had areas of missing plywood around attic stair entryway. If attic is going to be used as a storage area recommend installing plywood floor to avoid falling into the ceiling below.

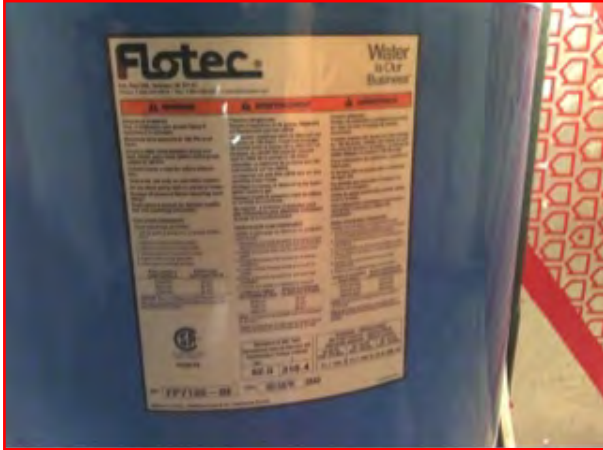
Figure 21-1

Electric control box is missing a cover for the well tank. Recommend electrician to find and install cover.

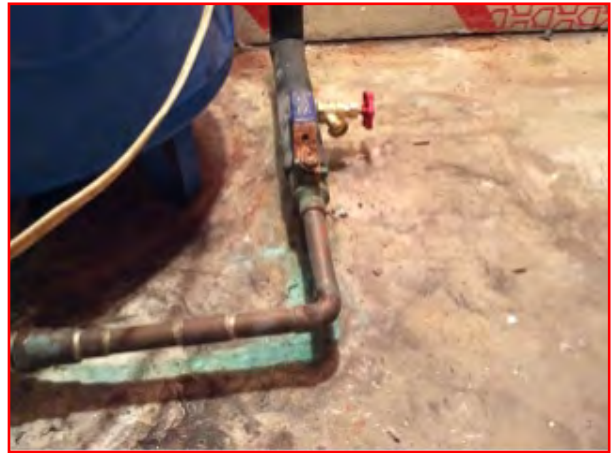
Figure 22-2

The well tank is in satisfactory condition with no visible signs of rust on the tank. Water was ran for 30 minutes and had adequate pressure. The main shut off lever for the water supply is rusted and corroded. Recommend plumbing contractor to evaluate and repair as necessary.

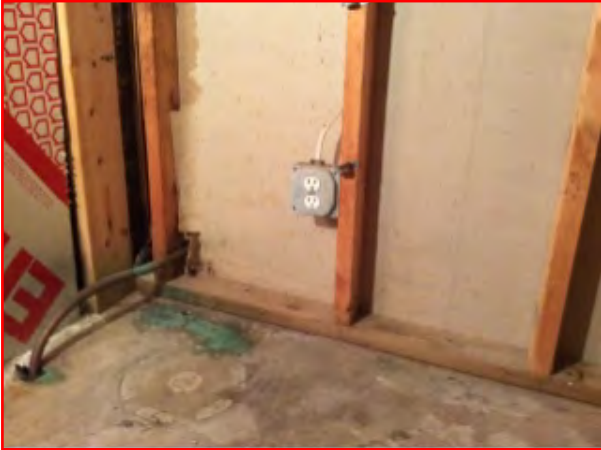
Figure 23-1

Electrical outlet is in close proximity to the well tank and is not a GFCI protected outlet. Recommend electrician to install GFI outlet.

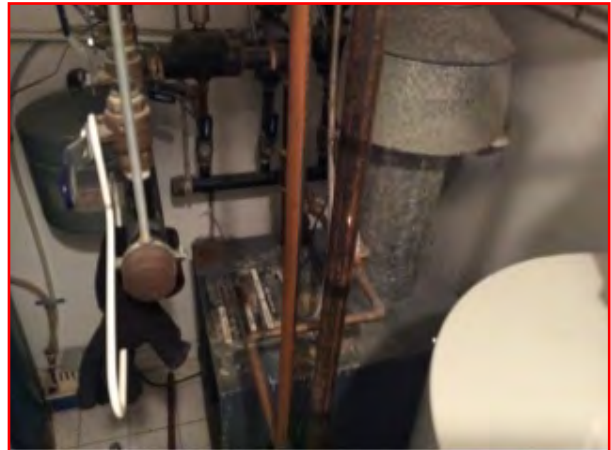
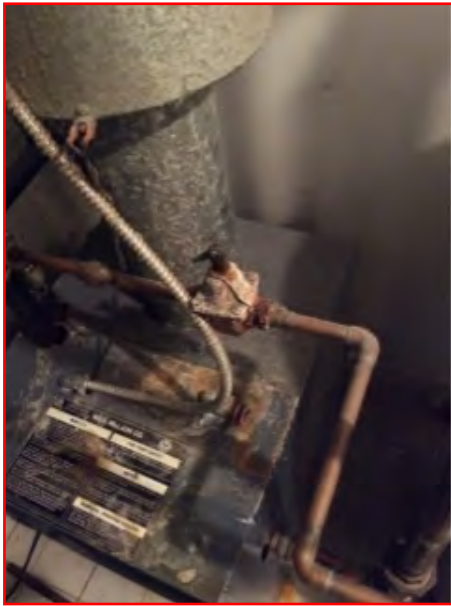
The pressure relief valve leading from the boiler to the hot water maker is rusted and there is evidence of water leak. There was no pipe extending to the floor for the TPRV on the boiler. Recommend plumber to repair as necessary

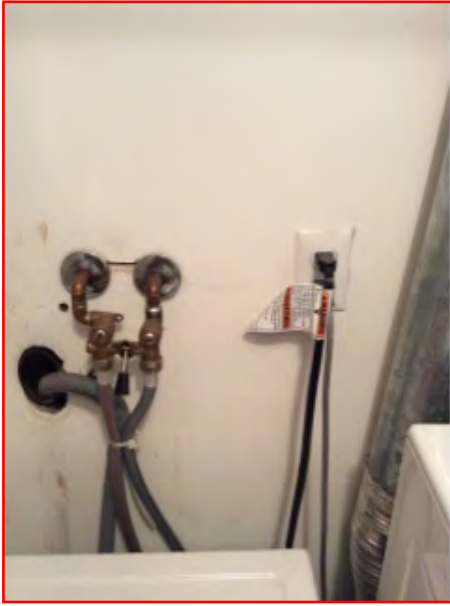
Figure 27-1

The outlet in the laundry room is in close proximity to the water source for the washing machine. This is a safety issue. Recommend electrician to install a GFCI outlet in laundry room.

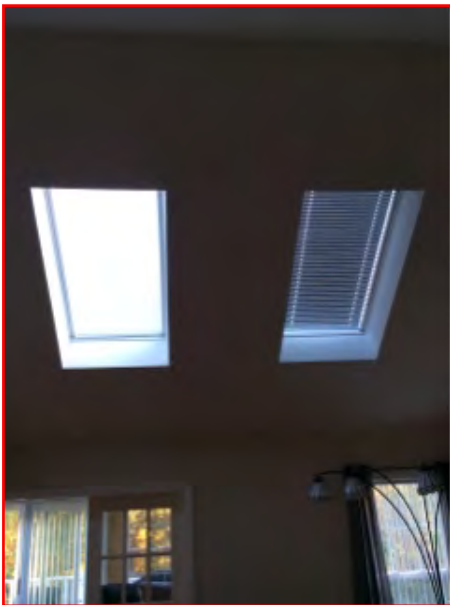
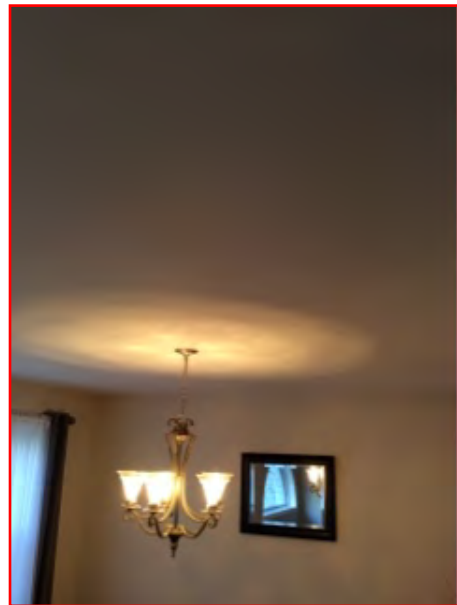
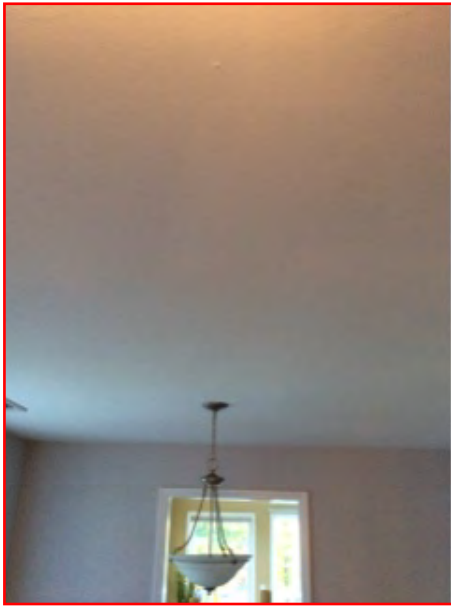
The interior was in overall good condition with no major defects noted. Ceilings and walls are sheetrock and are in good condition. All floor surfaces were level with no bounce and were in good condition. The electrical outlets were three pronged grounded outlets and randomly tested with no defects on the tested outlets. Windows are vinyl insulated and were randomly tested and operated properly.
